# HYDRAWRAP

STRUCTURAL COMPOSITE REPAIR SYSTEM

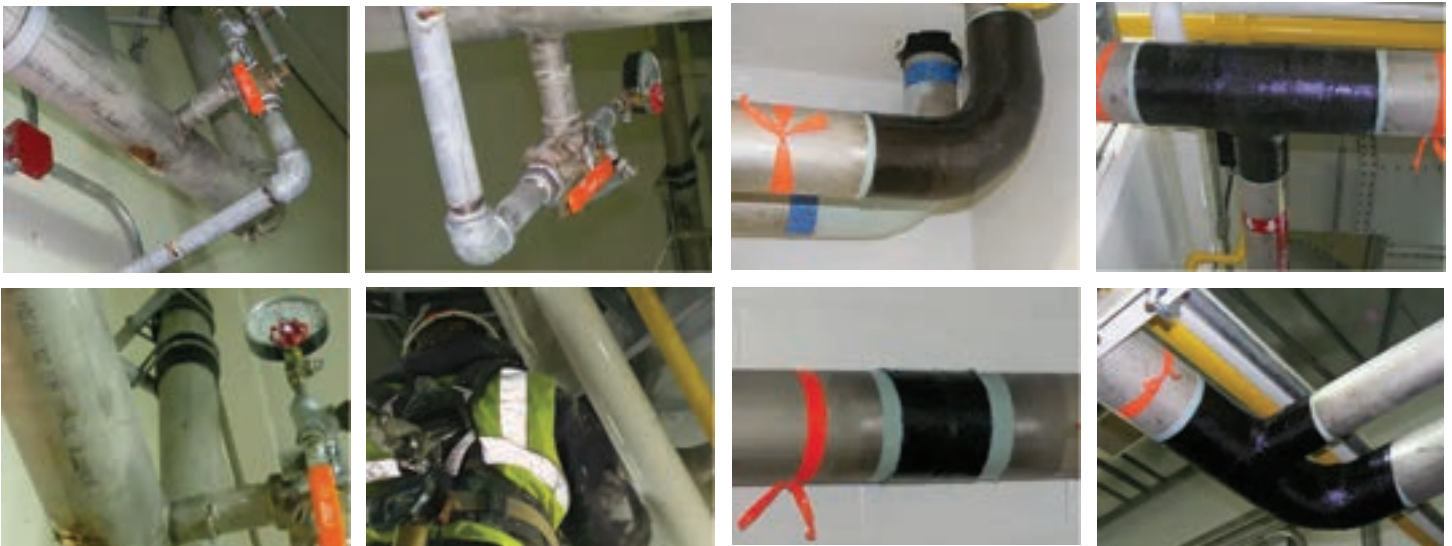
Various pipes in a water system in a hydroelectric dam had begun leaking. Defective welds were discovered to be the source of these leaks. A permanent solution was needed that was flexible enough to fit pipes of different sizes and shapes.

To eliminate the leak quickly and avoid costly replacement, a composite repair was chosen, 6" HydraWrap fabric with the standard epoxy.

Mechanical surface preparation was used at each location to ensure proper adhesion. The length of the repair was then marked using tape. Primer epoxy then coated the pipe's exterior. Carbon fiber fabric was wet out and then applied to the pipe. Some repairs required only 2 layers while other larger pipes or pipes with a higher operating pressure were wrapped with up to 4 layers. Nearly 100 points in this system were rehabilitated utilizing HydraWrap in roughly a month.

HydraWrap provided a long-term solution that was able to accommodate elbows, flanges, tee fittings, and straight portions of pipe. This repair was applied faster than replacement and at a fraction of the cost.
