# MARINE HYDRAWRAP STRUCTURAL COMPOSITE REPAIR SYSTEM

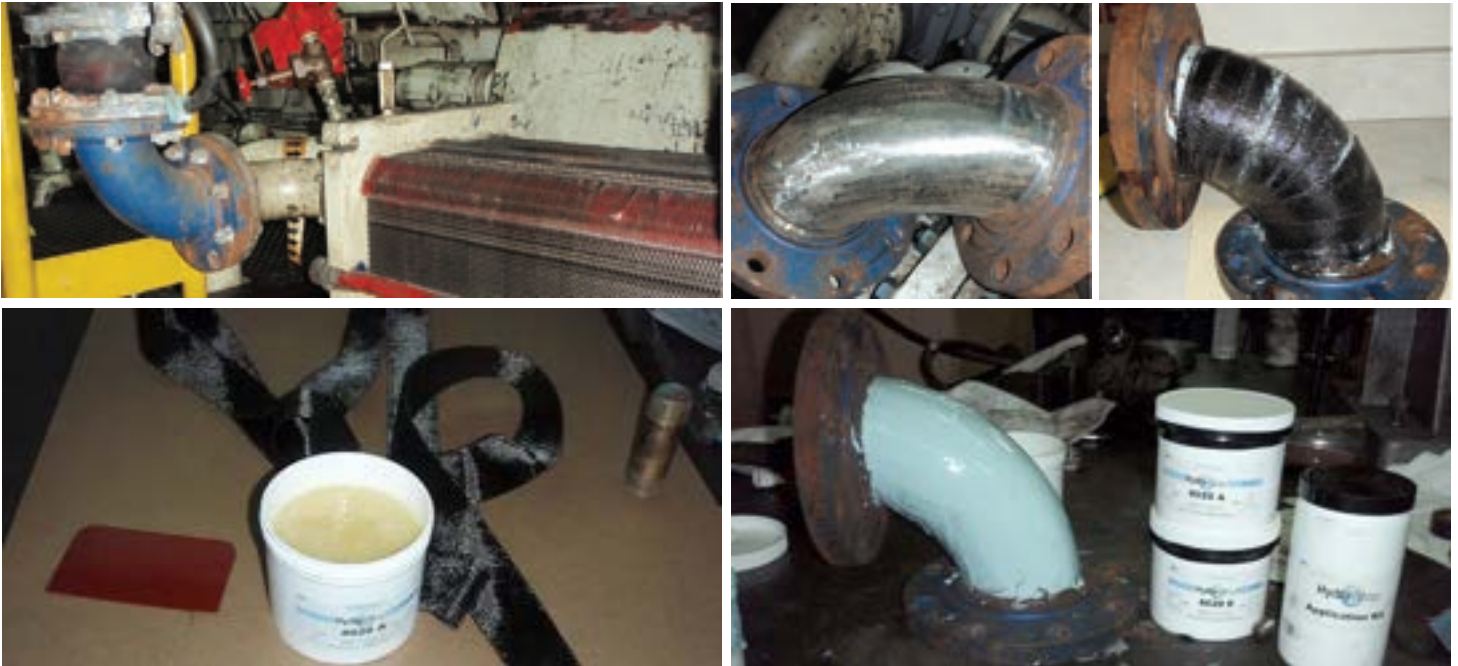
A pipe failure occurred onboard the MODU Quantum 4000 on the No. 5 main generator cooling water system. The leak, caused by corrosion, occurred on a carbon steel 4" SCH 80 short radius flanged elbow which is part of the saltwater discharge from a titanium plate heat exchanger. The system pressure is 40PSIG (2.75 bar) and the temperature is 105 F° (40 C°).

The Chief Engineer decided to repair the failed pipe elbow utilizing a 4" Marine HydraWrap elbow kit, a Design Approved by the American Bureau of Shipping for shipboard piping repairs.

The surface of the pipe elbow was surfaced prepped to achieve a mechanical profile. The HydraWrap FRP repair system was then applied in accordance with design standards.

The leak was quickly sealed and the pipe was returned to service. The crew was pleased with how easy it was to follow the directions for application. The repair will extend the service life of this pipe for years to come.
