INTERNAL PIPE

HydraTite®

JOINT SEAL

Stormwater

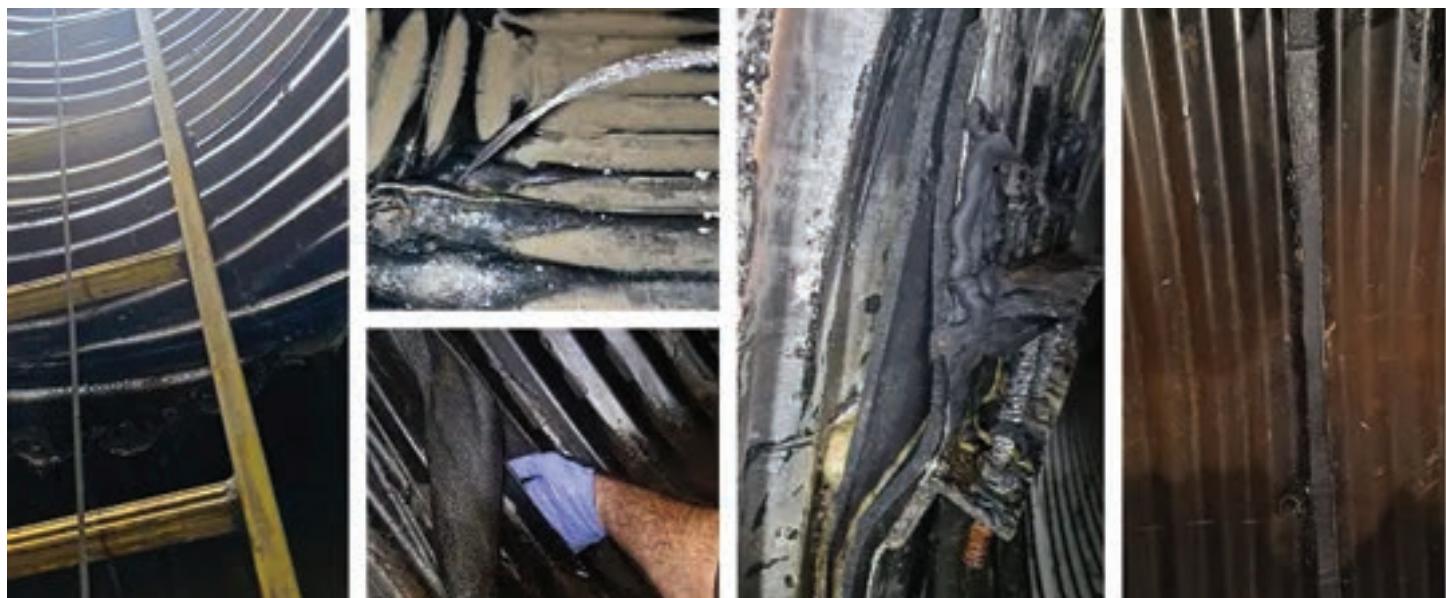
The project encompassed the repair of six stormwater retention tanks within 94.5" corrugated steel pipes. The scope included the custom fabrication of 45 HydraTite seals (42 standard-wide and 3 extra-wide), each installed with three retaining bands, and the application of gel injections for less

severe damage points. Before seal installation, the corrugated pipe surfaces were filled at the repair areas to create a smooth sealing surface, as required for proper HydraTite performance. Once the voids were filled, the rubber sleeve was placed over each repair point, the retaining bands were expanded to the specified pressure, and locked in place with a wedge, finishing the installation. Ciaran Gaughan was the foreman who oversaw the four-man crew for this installation. The entire project took 25 days, 20 of which were spent installing HydraTite seals.
