# INTERNAL PIPE HydraTite® JOINT SEAL

*Drinking Water*

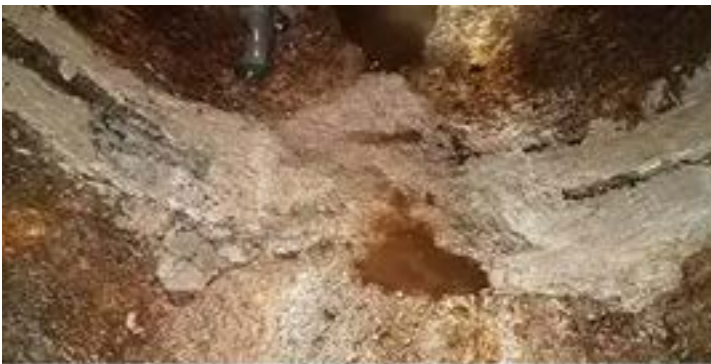
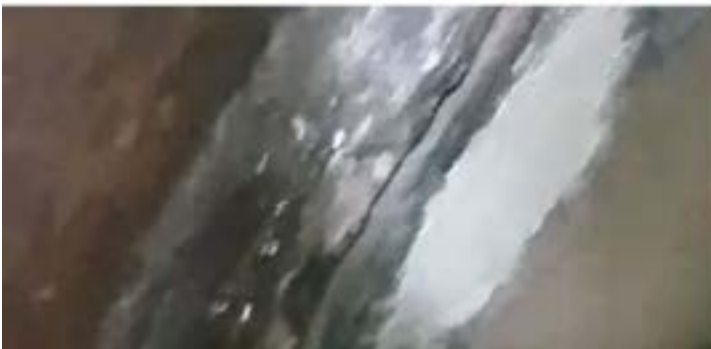
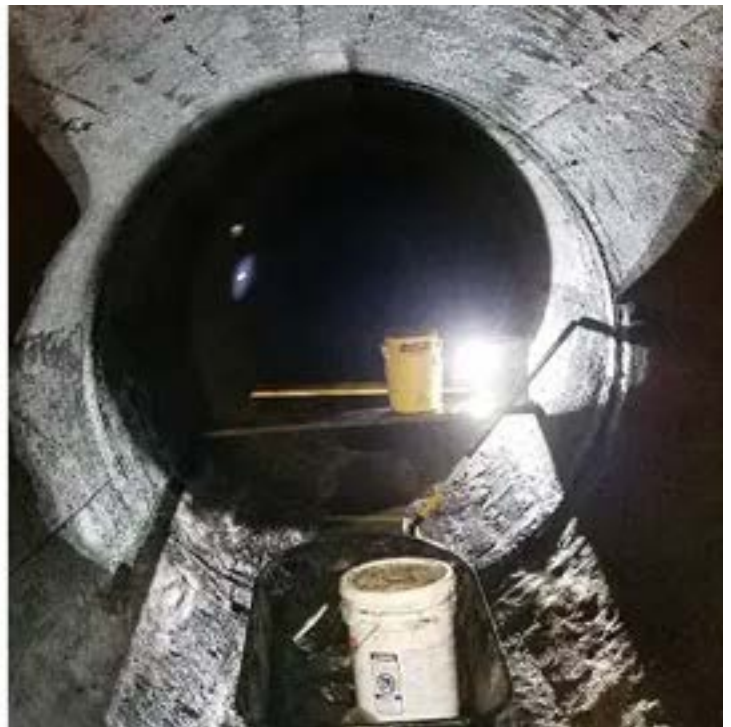
Inspection of a cast-in-place conduit from the early 1920s revealed 13 joints in poor condition, three of which had developed active leaks. This pipe was approximately 90" in diameter and was not perfectly concentric, incorporating a slightly flattened invert. A solution was needed quickly, that would cause minimal disturbance and downtime.

First, the water was pumped out. Next, the surface of the pipe had to be prepared near the pipe. Debris was cleared away and concrete was used to smooth out the irregularities of this old pipe's interior surface. Each seal was installed and then air tested. Some air tests revealed additional surface prep was required. These seals were deconstructed and more concrete was applied. The small crew had installed 13 seals that each passed the air test in only 8 days on site.
