INTERNAL PIPE

# HydraTite®

JOINT SEAL

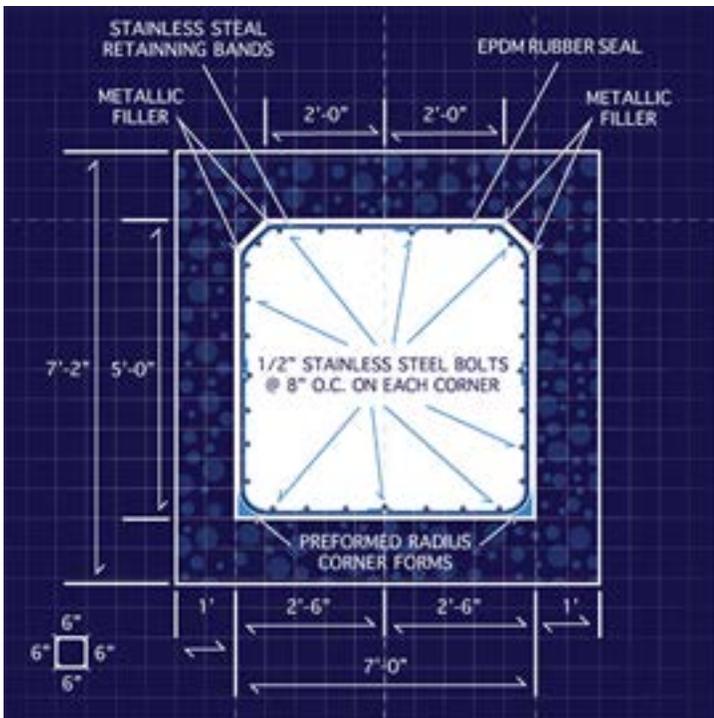
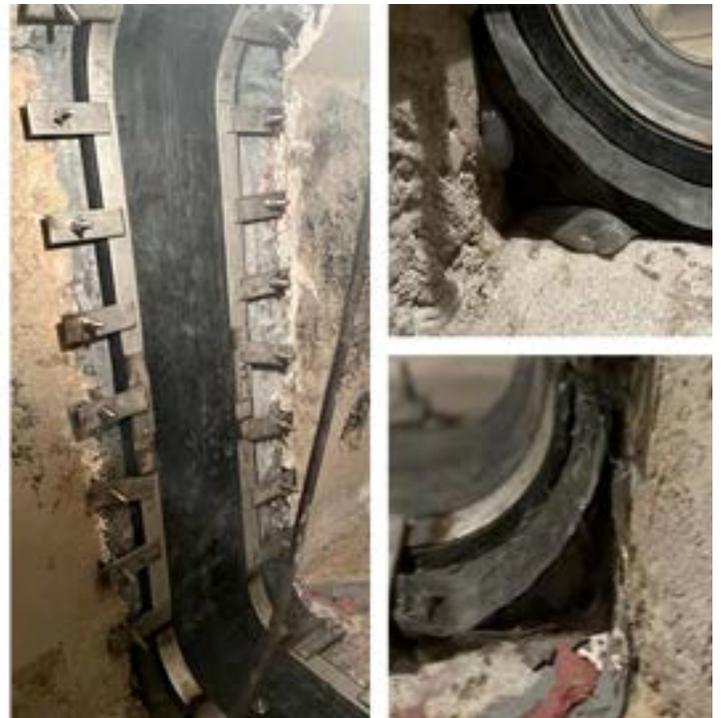
The engineer searched for a solution that would eliminate the leak and HydraTite's customizability made it the preferred solution. HydraTite could accommodate the irregular shape of the flume when installed with metallic filler in the top corners, preformed radius corners in the 90-degree bottom corners, and anchor clamps.

The power plant personnel completed the surface preparation and installation of the extra-wide HydraTite seal during the scheduled outage.
