# INTERNAL PIPE HydraTite® JOINT SEAL

DOT

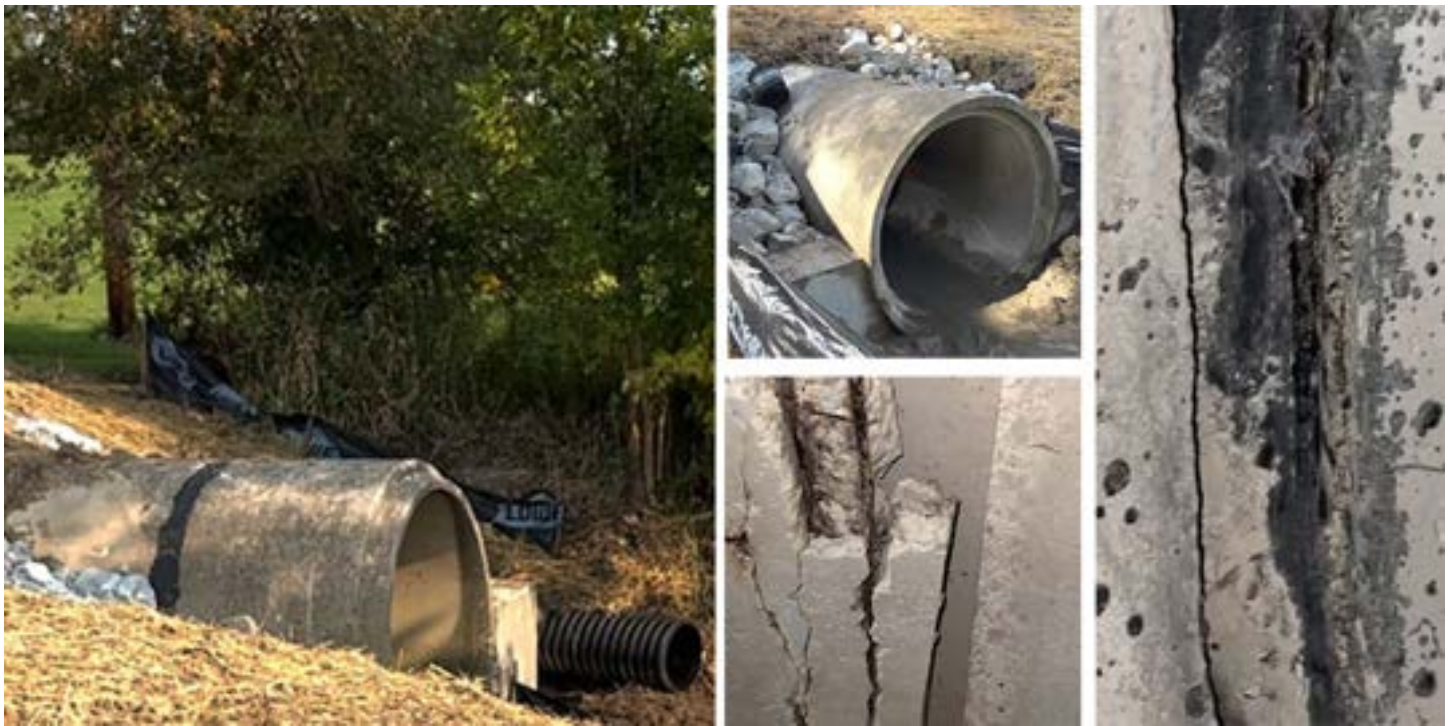
Two culverts were showing serious signs of degradation, especially at the joints. Spalling concrete had led to portions of pipe falling out near the joints. Almost every joint in these 60" and 72" culverts needed a repair that would not affect the traffic on the road above.

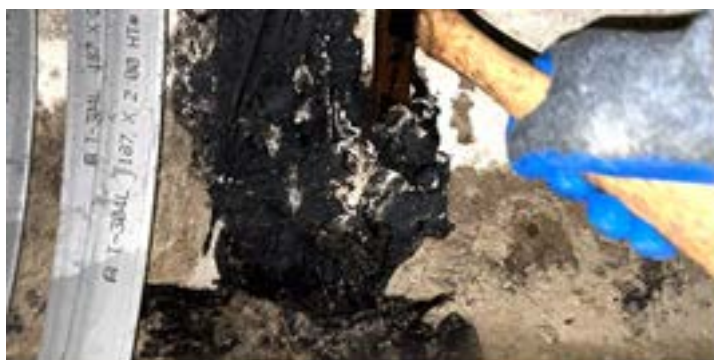
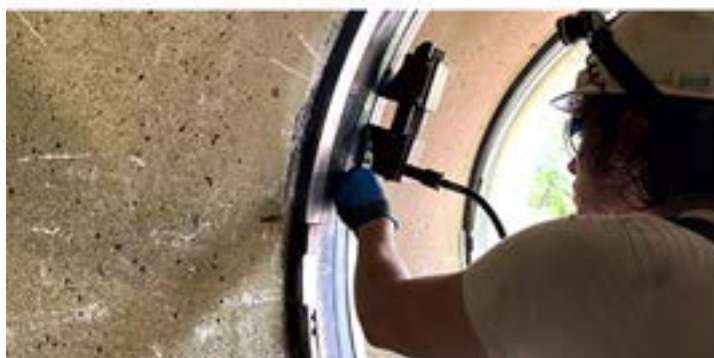
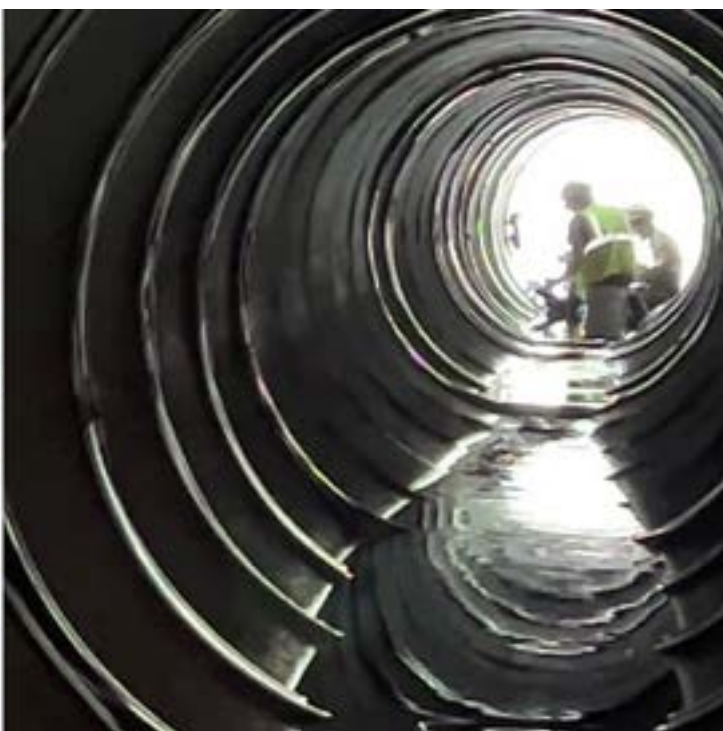
Both culverts were repaired following the same steps. Before the installation, damaged portions of pipe near the joints were smoothed out with concrete. Previous repairs that stretched beyond the joint were cut back closer to the joint to ensure the ribs of the HydraTite seal could effectively make contact with the host pipe's surface. Then the 33 seals were installed, 17 of the standard-wide seals in the first 60" culvert and 1 of the double-wide, 4 of the extra-wide, and 11 of the standard-wide seals in the 72" culvert. The wider seals were utilized to cover larger separations formed by the missing portions of the pipe joint lip. The entire process was completed in 3 days.
