# HydraTite®

JOINT SEAL

*Drinking Water*

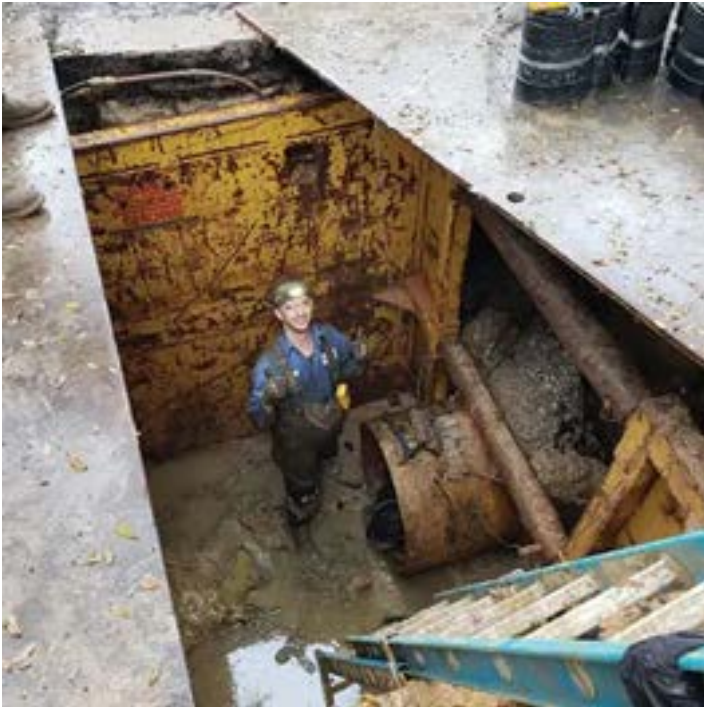
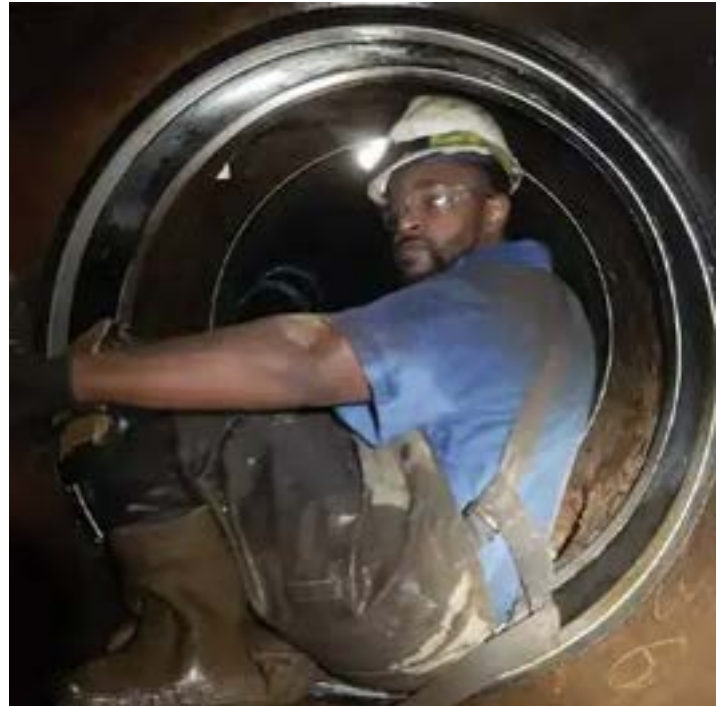
The mechanical Internal Joint Seal HydraTite was selected for the many needs of the water main. Seals of different diameters and differing thicknesses were employed for this project. Backing plates were used with the seals to cover the abandoned connecting 12" pipe and service taps.

The pipe had a low section that required dewatering. 1106 seals were installed throughout the entire water main. These were used to seal joints, unused service taps, and abandoned connecting pipes. Several seals were installed with backing plates.

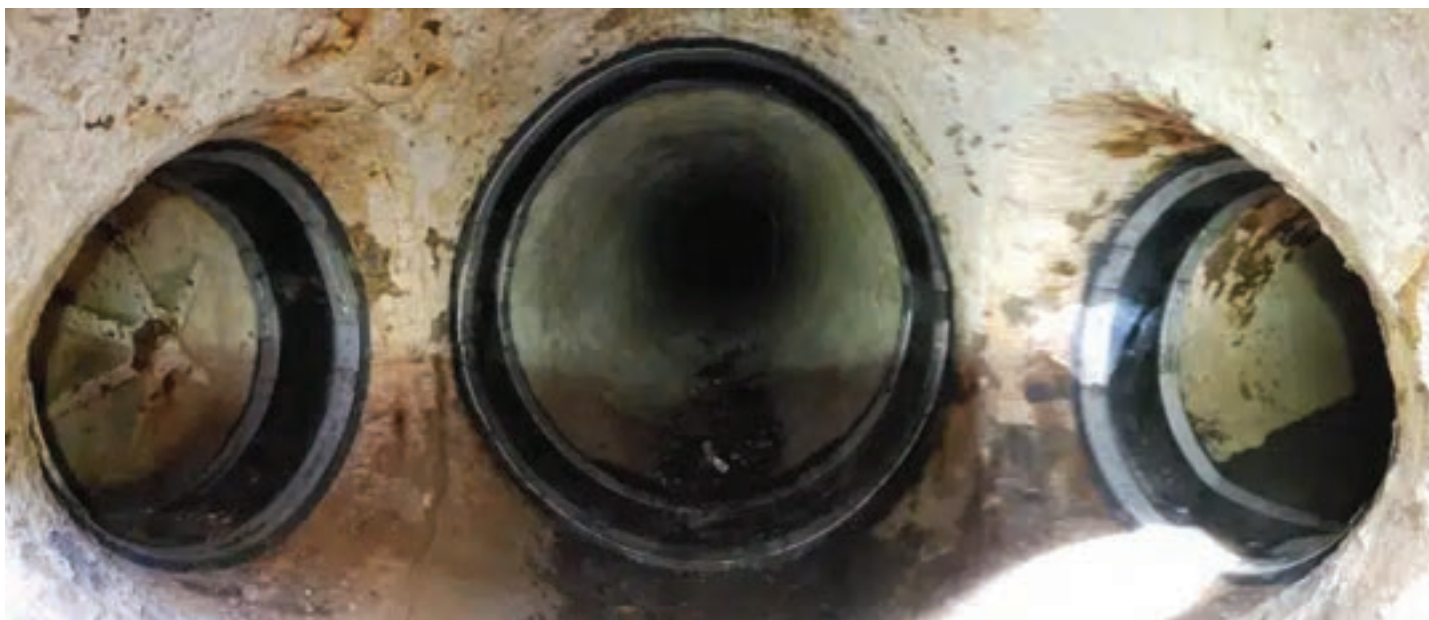
Our seals eliminated infiltration at all joints. HydraTite enabled a trenchless repair at a fraction of the cost of alternatives. None of the above trees or facilities were affected by the water main rehabilitation. HydraTite proved to be an economical in situ repair, making the operation of the penstock pipe more cost-effective.
