INTERNAL PIPE

# HydraTite®

JOINT SEAL

*Water & Utilities*

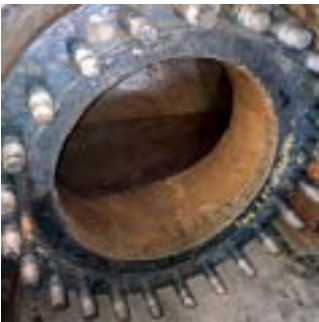
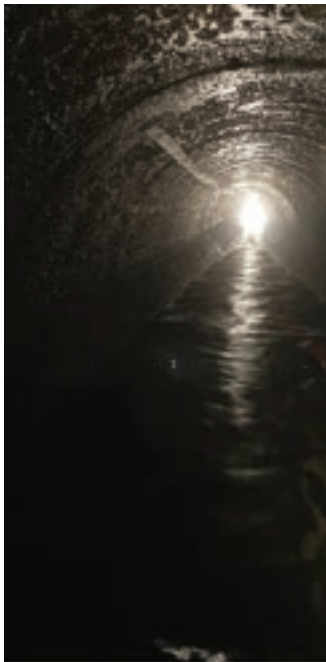
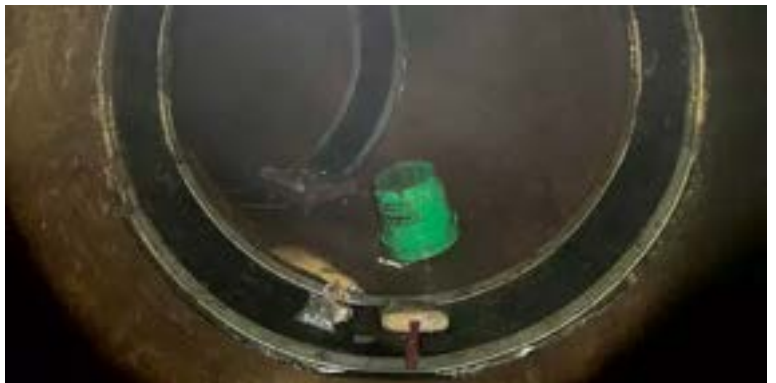
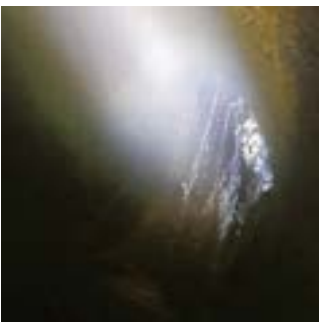
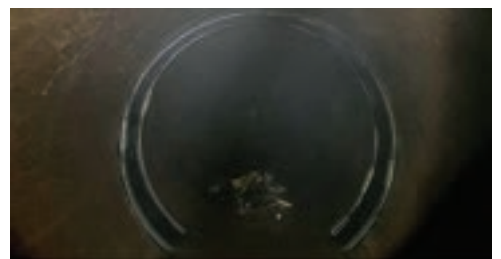
## Phase One

During the first mobilization, water had collected in portions of the first pipeline that dipped down lower than the rest of the pipe. This was pumped out and HydraTech's technicians navigated the twists and turns of the pipe to the most serious leak. Mineral build-up near the joint was cleared away with spackling knives to ensure a smooth sealing surface. The seal was installed and air-tested. Once this seal passed the air test, the crew made their way back out of the pipe. As they moved towards the exit they installed and air-tested three more seals. Once they climbed out of the pipe, it was closed and put back in use. In twelve hours the crew installed four seals.

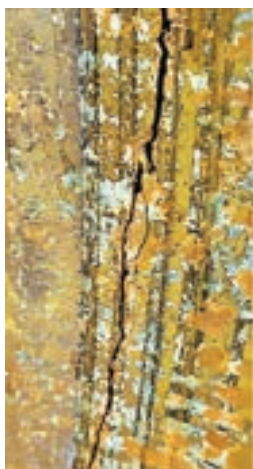
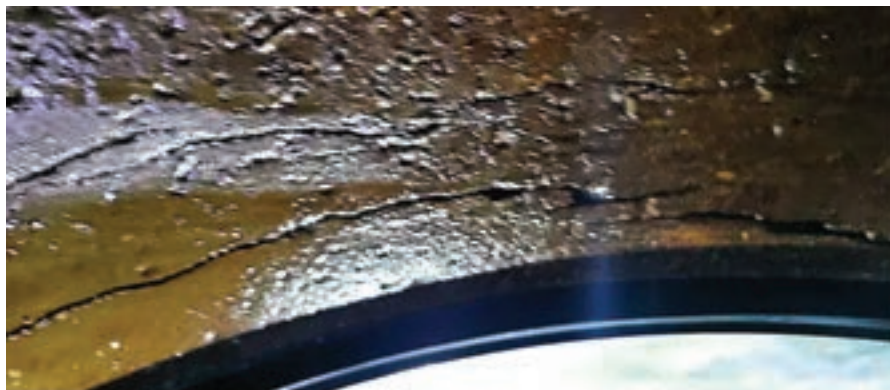
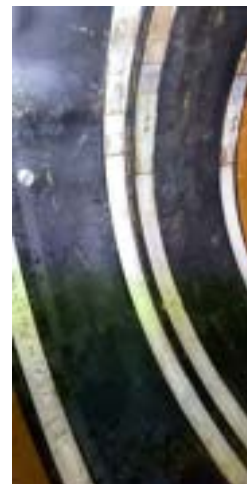
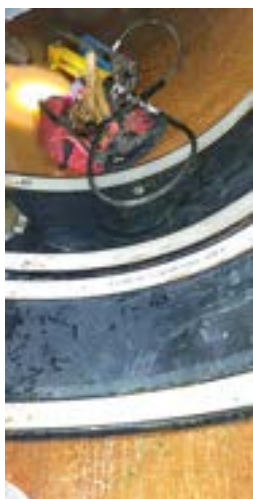
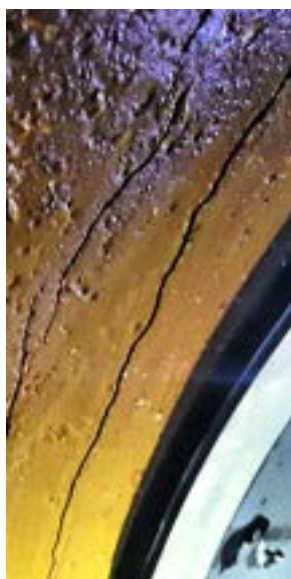
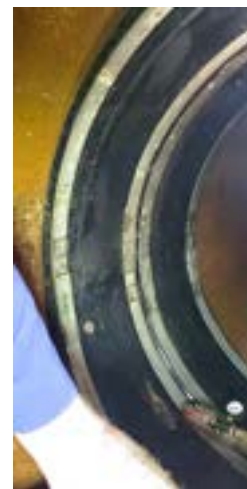
## Phase Two

During the second phase, the other two lines were worked on. Due to a previous surge in pressure, the second line had developed fissures near one of the compromised joints. This location required two seals installed right next to each other, one over the joint and one over the fissures. The crew started installing the five seals in the second line, but the third line was then shut down due to a decrease in water demand from those it supplied. The crew shifted to install the single seal in the third line and then returned to finish the second line's five seals. Both lines were rehabilitated in only three days.
