# INTERNAL PIPE HydraTite® JOINT SEAL

*Transportation*

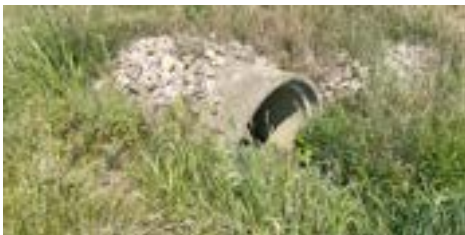
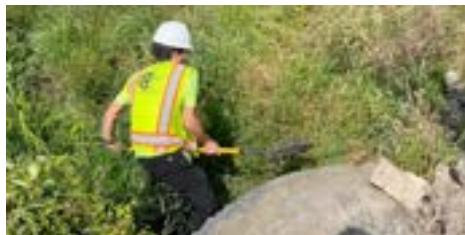
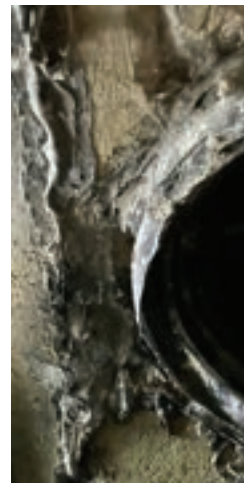
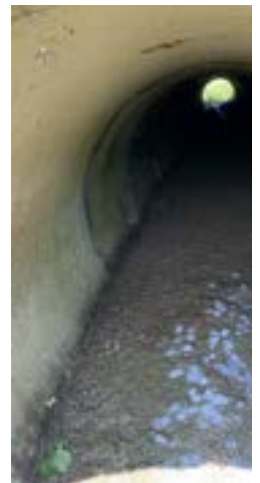
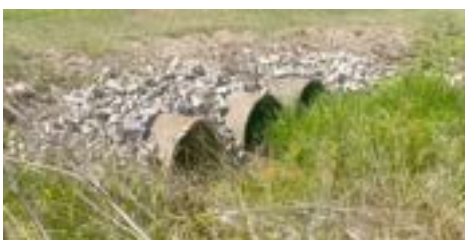
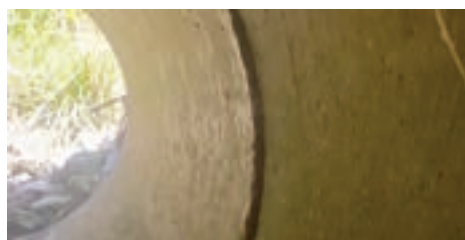
The DOT had discovered the road had slowly begun sinking above two culverts, indicating infiltration. Visual inspection confirmed that the pipe joints had become separated. Previously, some joints had been sealed using HydraTite, but budgetary restraints previously required that the most concerning joints be prioritized and only those be sealed. Now with a renewed budget, the remaining 45 joints needed to be fortified against infiltration. Just like last time, they needed a trenchless option to allow the regular flow of traffic to continue uninterrupted during the repair.

One location was a single culvert that had no previous HydraTite installations and the other was a triple culvert in which half of the joints had been sealed previously. This project involved the sealing of every remaining joint, 15 joints at the single culvert and 30 joints at the triple culvert. Both locations required circular seals, but they were sizes that were not normally stocked. The single culvert needed custom 54" extra-wide seals and the triple culvert needed 39.5" extra-wide seals. The triple culvert had a few rocks along the invert that needed to be moved and the single culvert's invert was covered in about a foot of mud that had to be dug out prior to installation. Both pipes' interior surfaces were in fairly good condition and required minimal surface prep before installation. One example of this prep was cutting back a smaller contributing pipe that fed into the 54" culvert. A HydraTite seal could not be installed properly because the contributing pipe protruded beyond the inner wall of the culvert. Once the joints were clean and the interior surface was uniform, the rubber was positioned over each joint. Stainless steel retaining bands were placed atop the rubber in its designated channels. A hydraulic expander was used to bring the retaining bands to pressure and a wedge was inserted to lock the bands in place. Due to other ongoing projects, the schedule was broken into two mobilizations, but 45 seals were installed in only 9 days onsite with only a crew of three onsite each day.

Extra-wide HydraTite Internal Pipe Joints Seals were the chosen solution to eliminate the leaks.

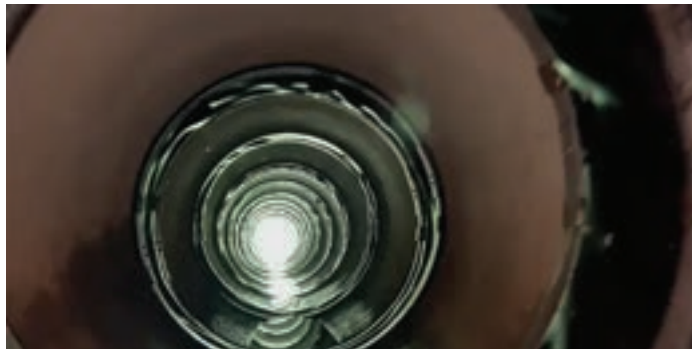
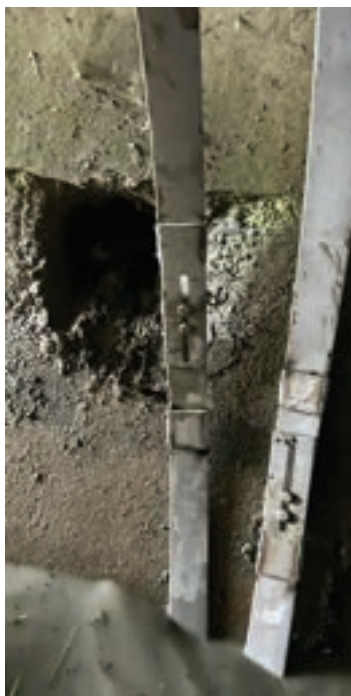
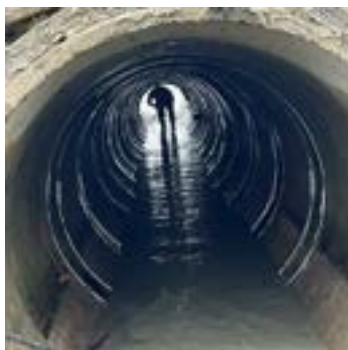
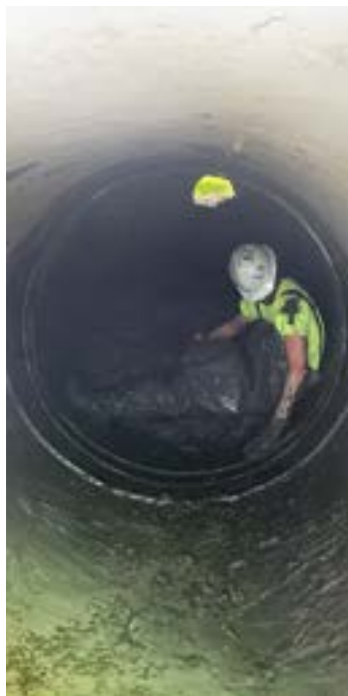
HydraTech custom-manufactured seals to perfectly fit these culverts and our field crew installed them quickly, providing a long-term repair for these 45 joints. The leaks were eliminated without disturbing traffic and the road will be protected against sinking any lower from infiltration.
