## MARINE HYDRAWRAP® STRUCTURAL COMPOSITE REPAIR SYSTEM

The challenge was to repair leaks in the cooling water supply pipe.

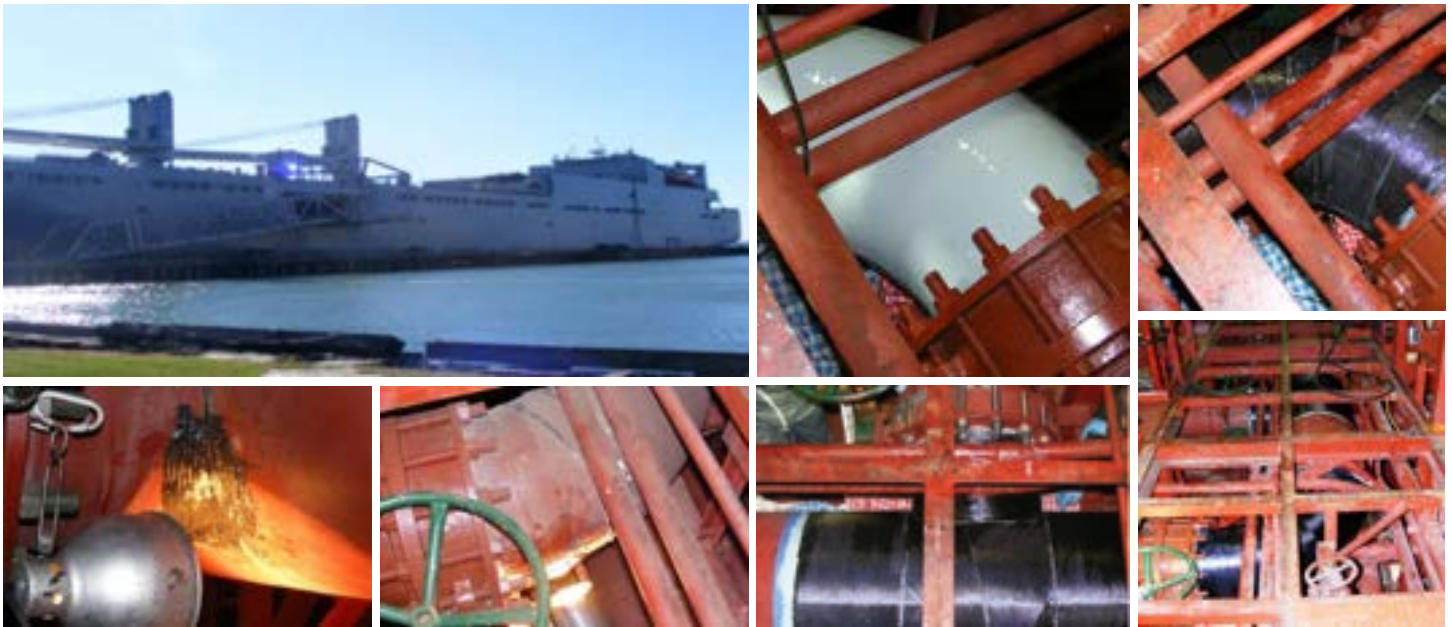
The cooling water system on a vessel experienced leaks and deterioration of the pipe wall. These leaks and deterioration were noticed primarily in the pipe fittings located immediately downstream of the supply pumps.

Temporary patches and repair bands were implemented in the past to reduce the leaking. Still searching for a better repair, the client was introduced to HydraTech's ABS Design Approved Marine HydraWrap®, and they requested the repairs be made to several areas of the system where leaks had developed. The areas of the CuNiFe piping were prepared and cleaned using hand and power tools to provide a clean surface and remove any foreign material. The HydraWrap® carbon fiber system was then applied.

HydraTech Engineered Products, LLC provided supervision and training services and the vessel's personnel completed the repairs on one 24-in x 18-in tee and one 18-in elbow in one working day.
