# INTERNAL PIPE HydraTite® JOINT SEAL

Power Generation / Hydroelectric

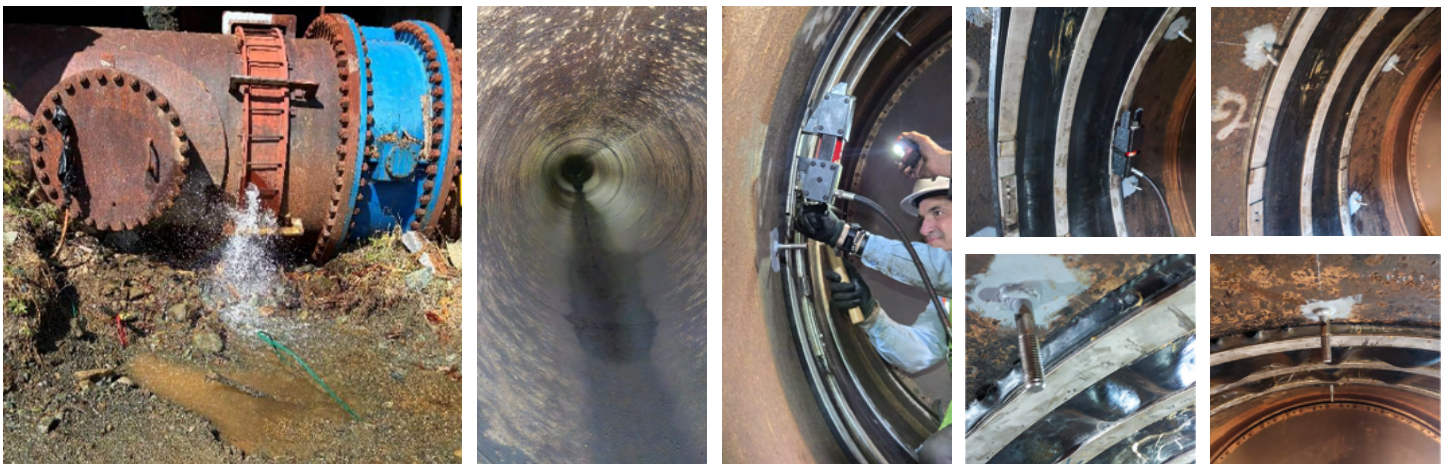
HydraTech engineered a custom 72-inch double-wide EPDM HydraTite® Internal Pipe Joint Seal to span the leaking pipe coupling. The seal was supplied with three 2-piece 316 stainless steel retaining bands, providing mechanical compression around the full circumference of the penstock. Project documentation confirms the custom 72-inch double-wide configuration and three-band stainless steel retention system.

Because of the high-pressure application and concern surrounding downstream movement if the seal were ever to become compromised, the design incorporated eight supplemental stainless steel retaining braces over the completed HydraTite® assembly. These braces provided a secondary means of restraint intended to prevent the seal from traveling downstream even in the event of a future failure. The additional restraint components were incorporated into the project before shipment.

An owner-supplied two-person crew performed the installation under the supervision of HydraTech's technical engineer. The double-wide EPDM sleeve was positioned over the pipe coupling, and three 2-piece 316 stainless steel retaining bands were expanded against the interior of the 72-inch penstock to mechanically secure the rubber.

Once the HydraTite® assembly was secured, the supplemental stainless steel braces were connected to the previously installed studs above the seal, providing the additional restraint required for the application. From the beginning of seal installation through completion, the process took approximately three to four hours.
