INTERNAL PIPE

# HydraTite®

JOINT SEAL

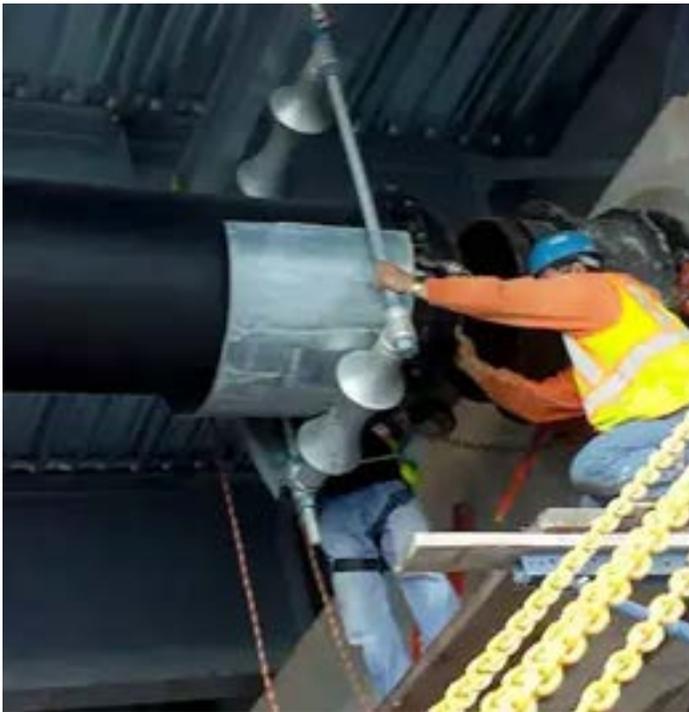
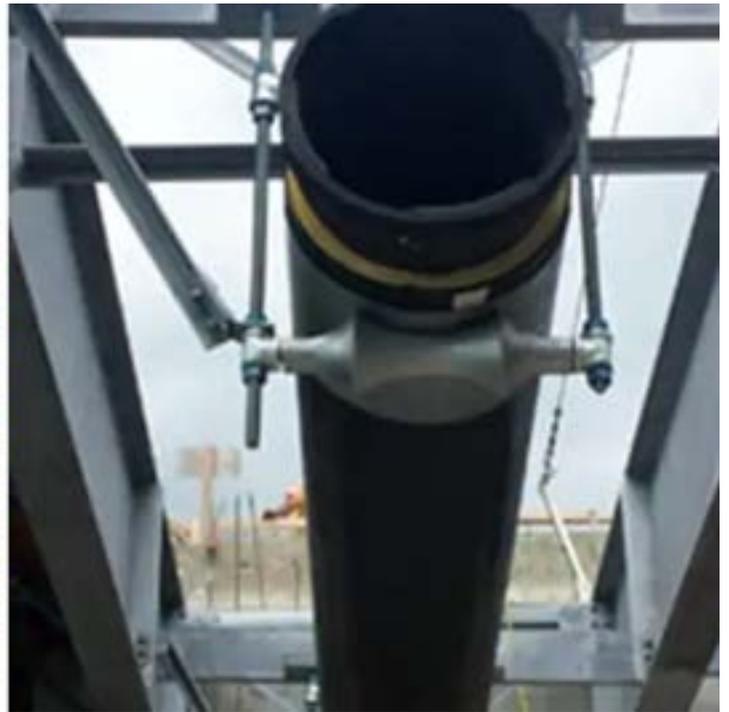
The 24" diameter pipe presented limited access and restricted clearances. The pipe was supported off a bridge, so access had to be coordinated with the pipe installation contractor. Cold weather hindered work because ice formed inside the pipe at the repair locations.

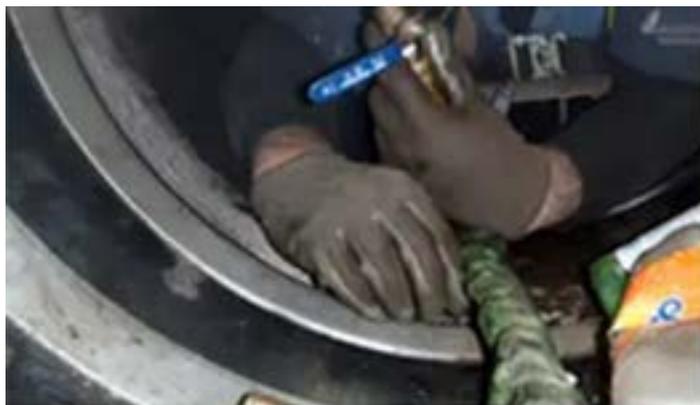
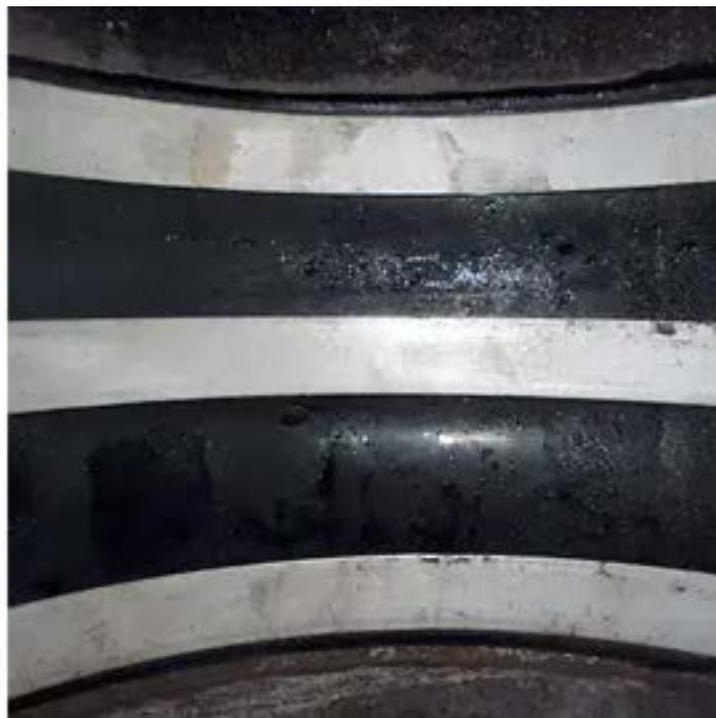
The mortar was removed prior to installing HydraTite®. Nine joints were then repaired, at times separated by over 200 feet. Sections of pipe were removed to provide access from suspended scaffolding. The pipe was then reassembled, and the pressure test was successful. HydraTite® stopped the leaks for less than 5% of what it would have cost to replace the piping.
