**HYDRAWRAP**  
STRUCTURAL COMPOSITE REPAIR SYSTEM

A 102" Prestressed Concrete Cylinder Pipe (PCCP) that was part of a recirculating cooling water line at a fossil fuel power generation station had begun to show signs of aging. A joint had become separated and was visibly deteriorated. During the inspection, broken and missing portions of mortar were found.

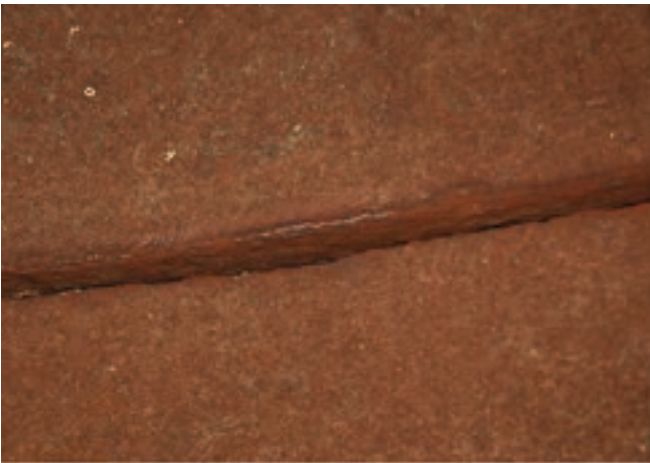
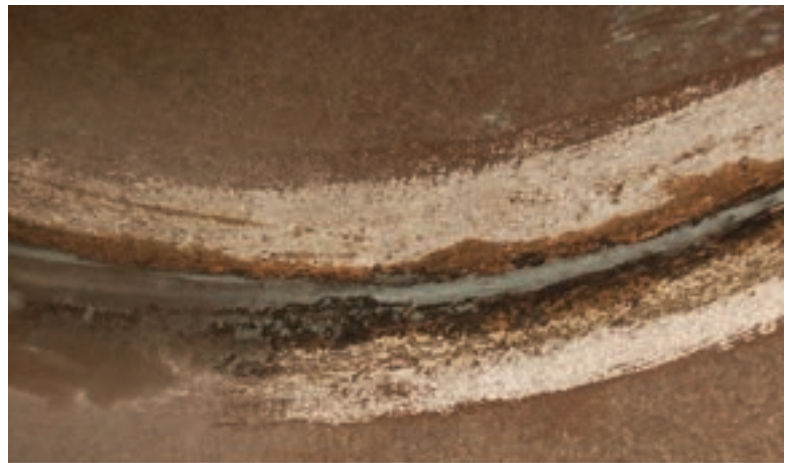
Cement-based filler was placed in the joint and the surface of the pipe leading up to the joint was prepared with a wire wheel. Then the HydraWrap epoxy was applied to the joint and allowed to cure. The EPDM rubber was placed over the joint and the retaining bands expanded into place. The seal was then air tested.
