INTERNAL PIPE

HydraTite®

JOINT SEAL

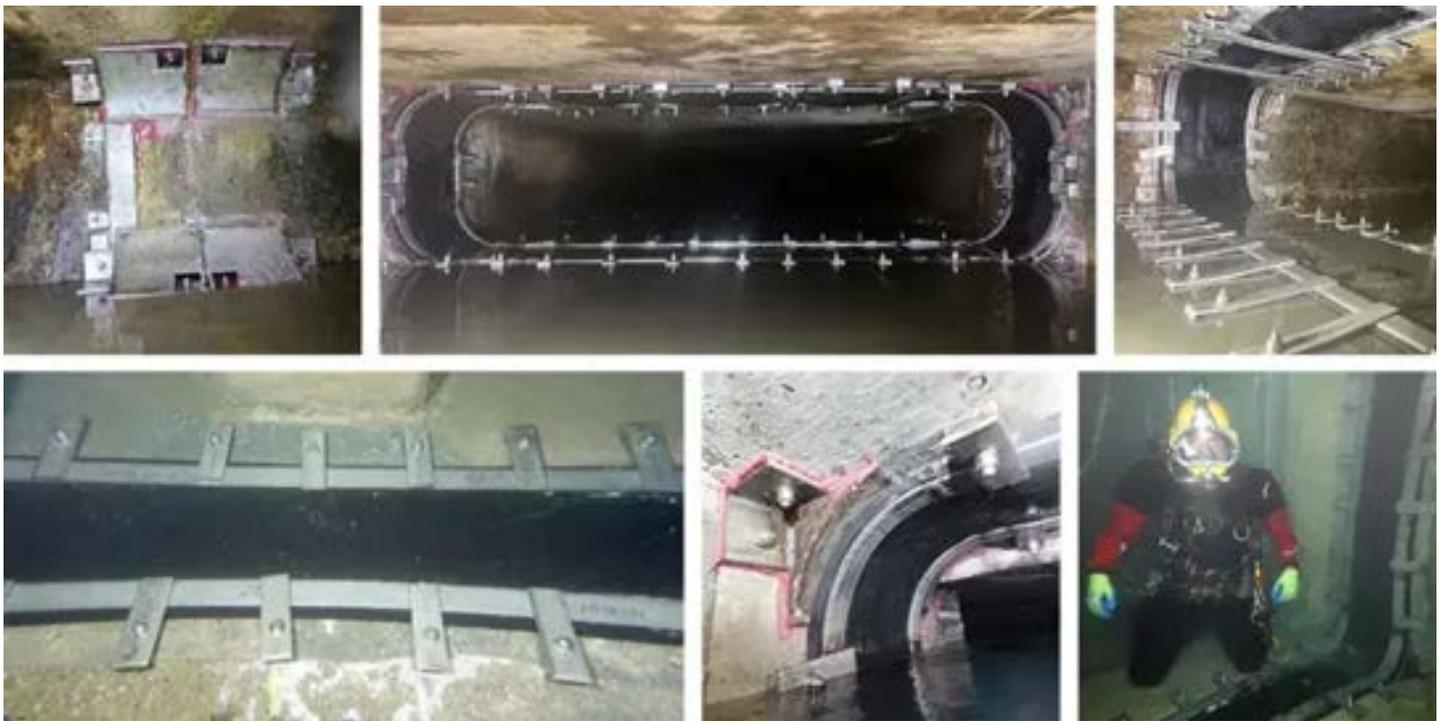
Two divers installed five seals and each seal was installed in 1 to 2 days each. 4 of the seals were installed without the pipe being dewatered. The interior surface of the pipe near the joints was prepared for installation by smoothing out all irregularities. In a couple of instances, the walls of the basin were sloped and steel spacers were used to plumb up the seal. The rubber was positioned over the joints. The retaining bands were then expanded, locking the rubber in place. The box seals required corner forms to be put in place to assist in the rubber's transition over the 90-degree corners. Then sealant was applied to the edge of the corner forms. Anchors were drilled for the box seals as well. 2 of the 60" extra-wide circular seals were installed. The basins each required different sized seals. A 127" by 73" extra-wide seal, a 108" by 73" double-wide seal, and a 108" by 28" double-wide seal were all installed.

HydraTech custom-manufactured seals that will provide a long-term repair for these 5 joints. They were installed quickly and most were installed underwater. The leaks were eliminated and the facility has had success using this repair method on other joints that were not in the scope of this project as well.
