INTERNAL PIPE

HydraTite®

JOINT SEAL

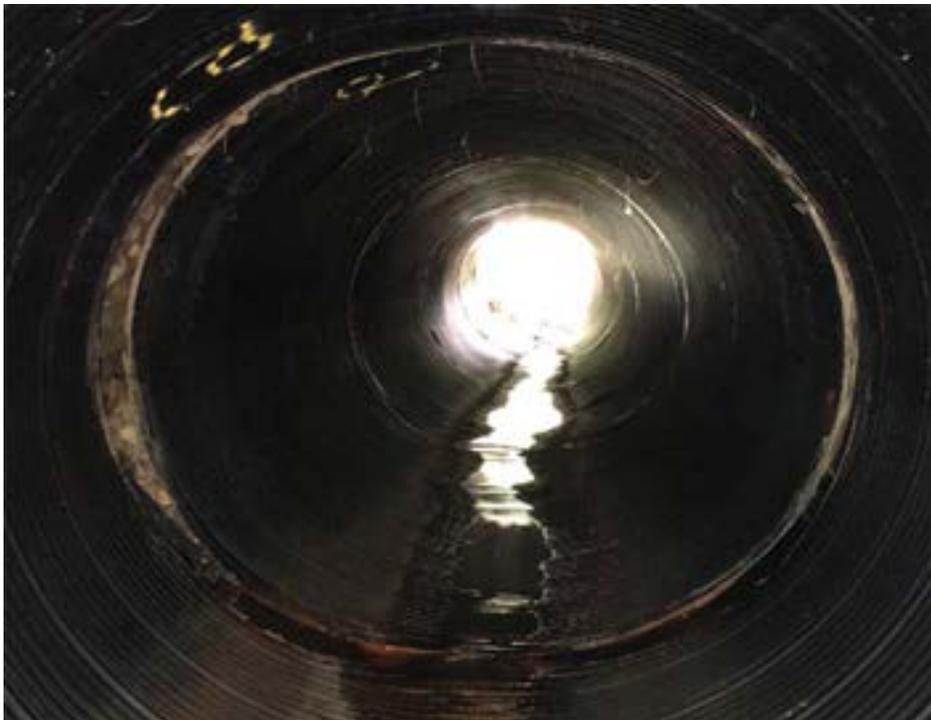
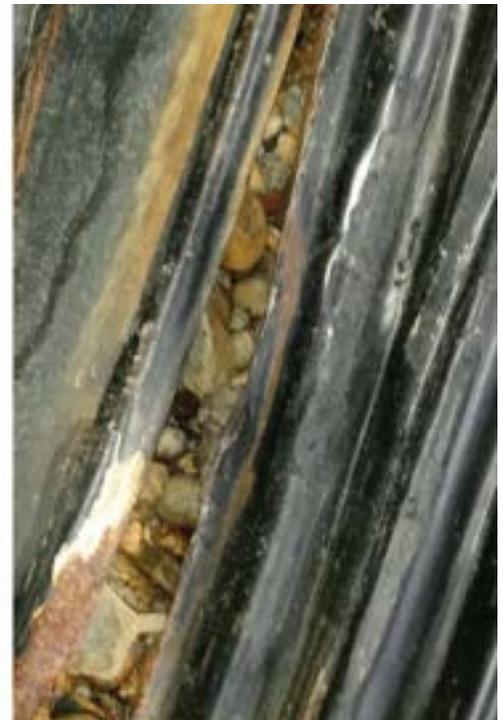
A culvert in New Vineyard, ME had a significant infiltration problem at two pipe joints which led to culvert joint separation, erosion issues, and pavement settlement. The infiltration at the joints had caused the backfill around the pipe to create a void around the joint and cause the pavement to settle. The corrugated metal culvert had been replaced 15 years ago, however, it was improperly backfilled and the joints were not watertight. Over time the infiltration caused the pipe to settle as well as the backfill to infiltrate into the pipe.

The job consisted of the installation of 2 HydraTite Seals that were 108" in diameter to eliminate infiltration as the two joints that had failed. The surface was filled with rubber to provide a smooth surface for a watertight seal solution.

HydraTech implemented an engineered solution to address these issues. Although the HydraTite Seals are installed on smooth wall pipes to prevent infiltration they can also be designed for corrugated surfaces. The Flexibility of the HydraTite seal makes it a great option for eliminating infiltration without having to disrupt traffic or bypass the pipe.

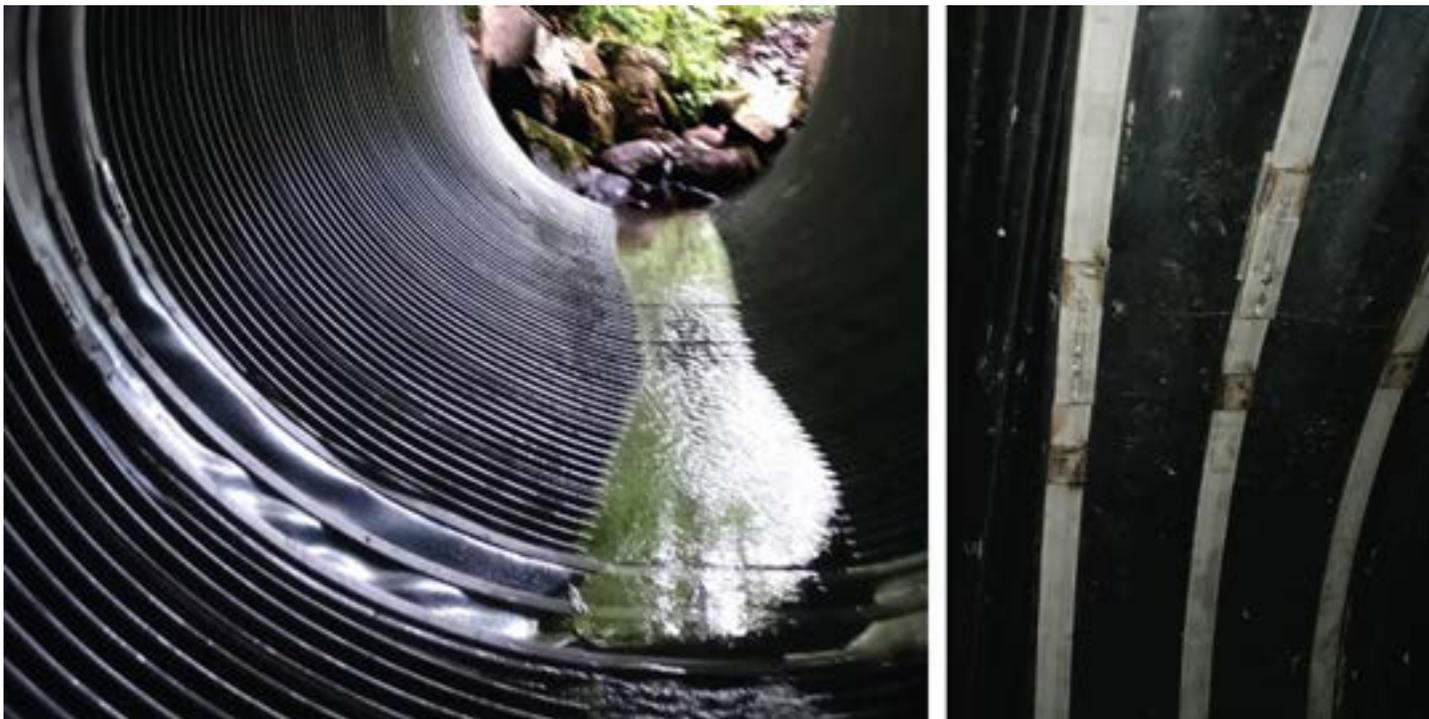
HydraTite enables a trenchless repair at a fraction of the cost of fully lining the pipeline or excavation. The sealed joints eliminated infiltration and stopped the settlement of the pavement. The job was done quickly and without disruption to traffic. HydraTite is a solution not only for failing concrete joints but corrugated metal drainage pipes as well.
