# HydraTite®

JOINT SEAL

A water treatment plant in western Ohio was confronted with repairing leaks of costly treated water from an underground transfer chamber, without draining the system.

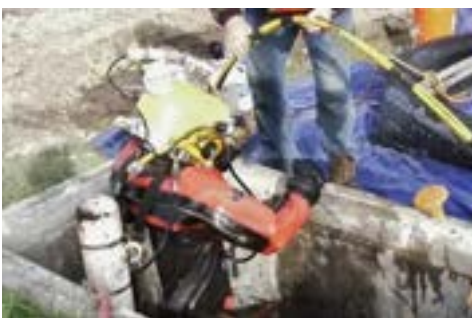
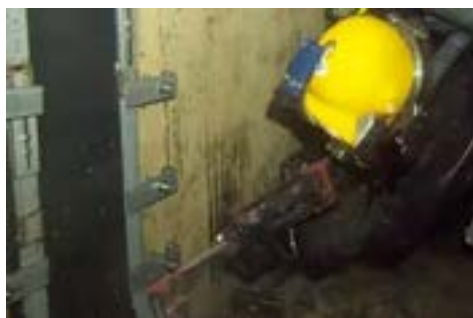
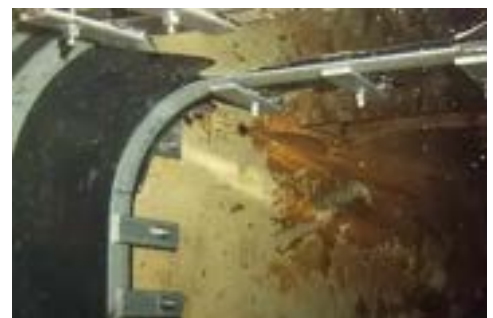
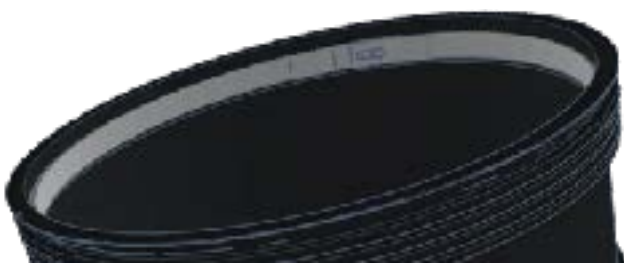
During an inspection performed by divers, a total of five (5) construction joints in various reinforced concrete transfer chambers were identified as the sources of the leaks. The corners of the square cross section chambers required prefabricated stainless steel forms to produce the required radius. The straight sections of the HydraTite® seal are equipped with anchor clips.

Divers, after training on the installation of the HydraTite® seal, prepared deteriorated surface areas on either side of the joints and installed the HydraTite® seals with the furnished stainless steel forms and anchor clips.
