# INTERNAL PIPE HydraTite® JOINT SEAL

**Market**  
*DOT*

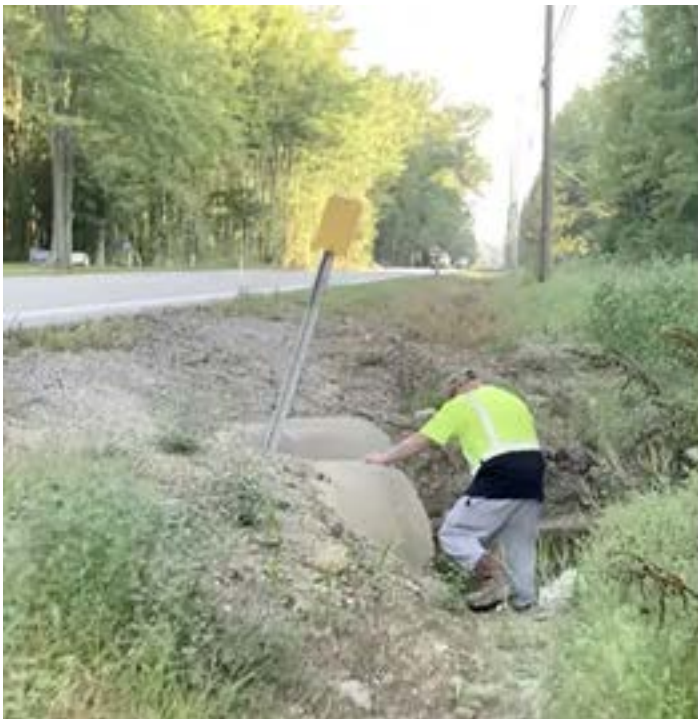
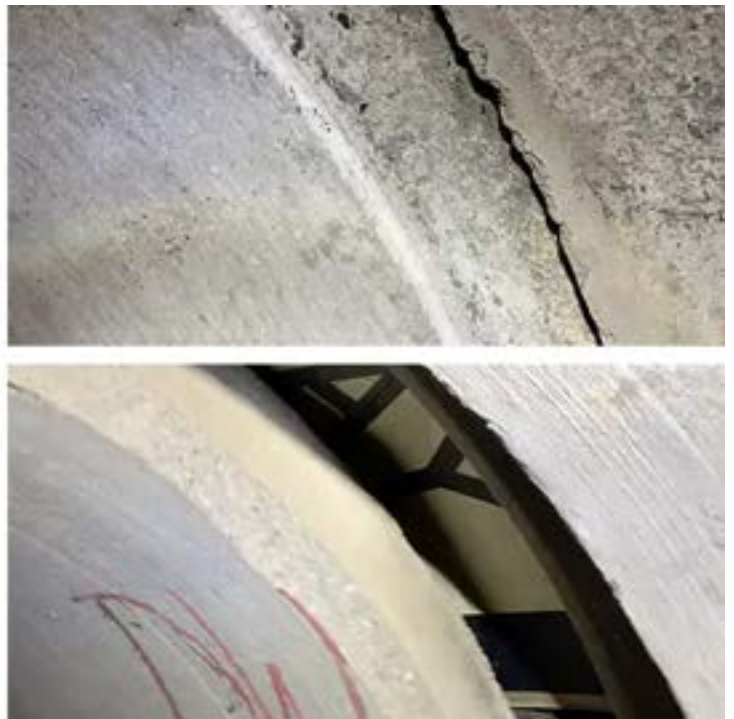
A 42" reinforced concrete storm culvert beneath a highly traveled roadway had joints that were separated and offset resulting in erosion of the surrounding soil. One joint was so severely separated that sunlight was entering the culvert. The concern was that sinkholes would likely develop and the above road was threatened if the erosion continued.

Four Extra-Wide and Six Double-Wide HydraTite Internal Pipe Joint Seals were the chosen solution. The Double-Wide seals' larger width would accommodate the joints with more severe separation and offset.

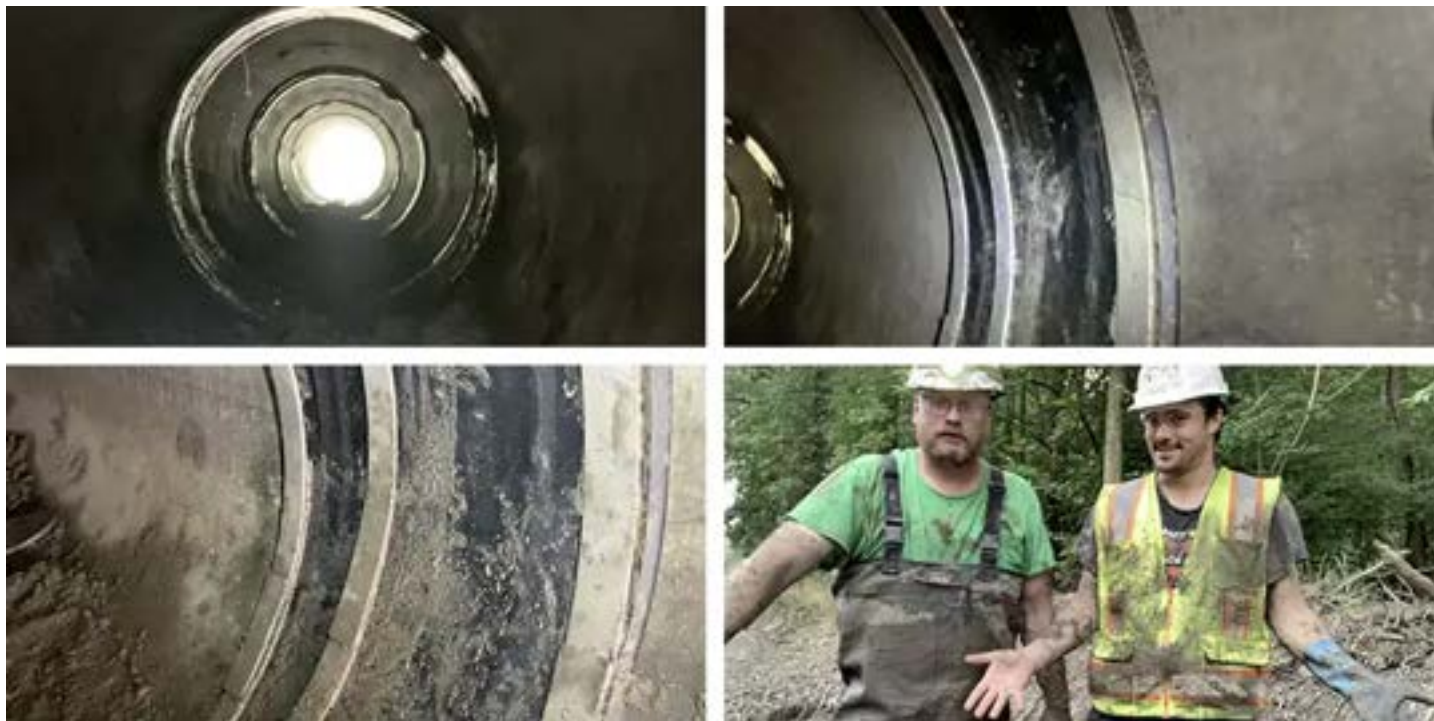
HydraTite seals provide a trenchless repair at a fraction of the cost of excavation or fully lining the pipeline. As in many cases, the pipe was good, but the joints were bad. The sealed joints eliminated erosion and protected the above road. The job was done quickly and without disruption to traffic.
