# INTERNAL PIPE HydraTite® JOINT SEAL

*Water & Utilities*

A water treatment plant discovered leaking joints in their influent pipes and basins that were part of the filtered water conduit. These systems were structurally sound but compromised at the joints. A targeted repair that could be installed without the system being dewatered was preferable.

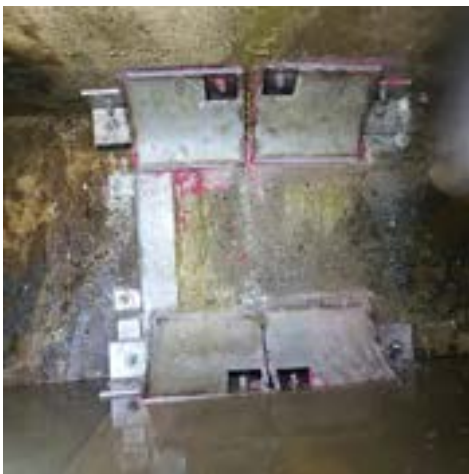
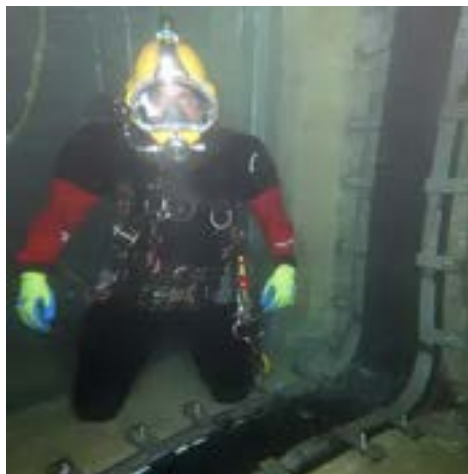
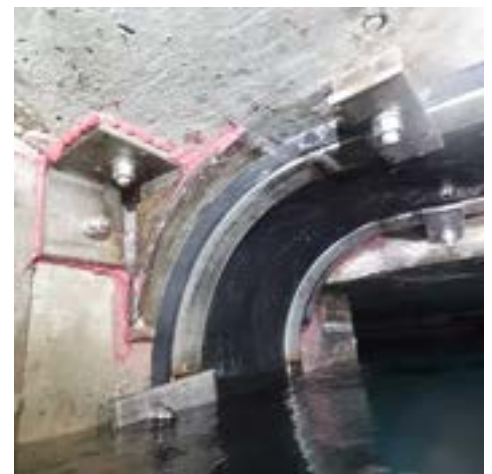
Two divers installed five seals and each seal was installed in 1 to 2 days each. 4 of the seals were installed without the pipe being dewatered. The interior surface of the pipe near the joints was prepared for installation by smoothing out all irregularities. In a couple of instances, the walls of the basin were sloped and steel spacers were used to plumb up the seal. The rubber was positioned over the joints. The retaining bands were then expanded, locking the rubber in place. The box seals required corner forms to be put in place to assist in the rubber's transition over the 90-degree corners.

Then sealant was applied to the edge of the corner forms. Anchors were drilled for the box seals as well. 2 of the 60" extra-wide circular seals were installed. The basins each required different sized seals. A 127" by 73" extra-wide seal, a 108" by 73" double-wide seal, and a 108" by 28" double-wide seal were all installed.
