**Market**  
*DOT*

Construction on a subdivision began over a decade ago, but due to financial restraints, the project was put on pause until recently. As a result, RCP stormwater pipes had been installed but never put into use. Now these pipes needed to be brought up to code, ensuring they would function properly. Replacement would be exorbitant and the pipes were structurally sound so a trenchless repair was preferable. The solution would need to be installed without affecting the other construction projects.

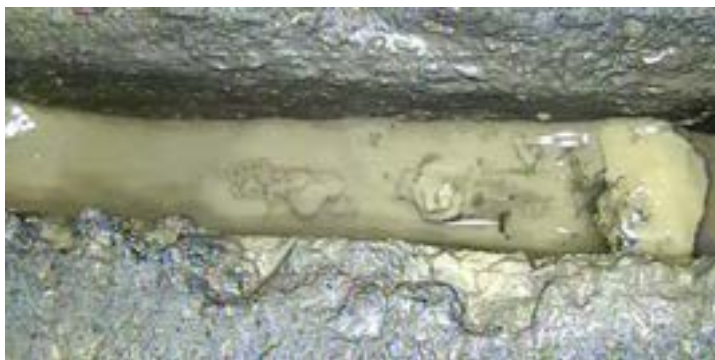
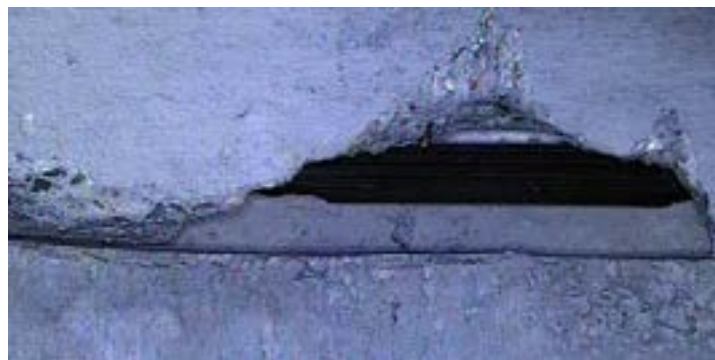
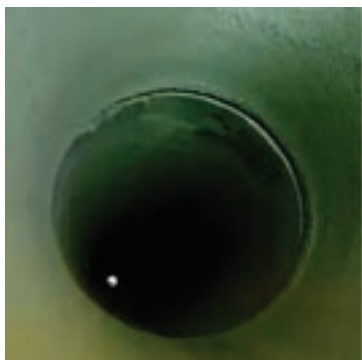
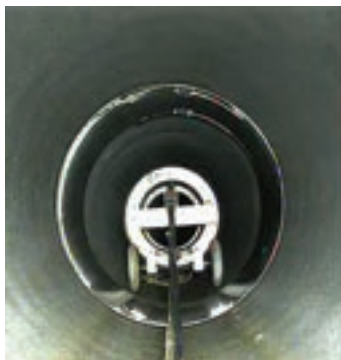
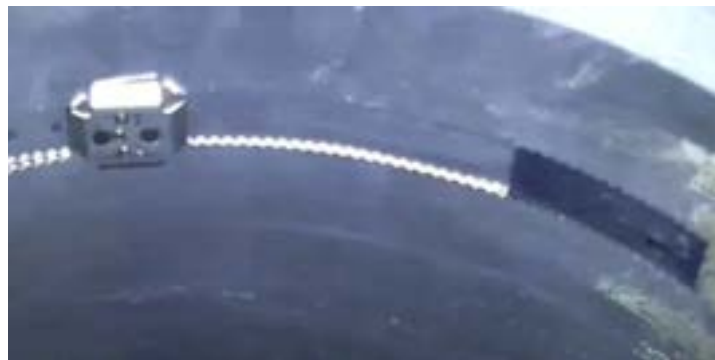
Six joints were marked for repair in the 18" pipe. Four of the joints had separation and two of them had exposed gaskets and minor concrete damage. Atlantic Pipe Services used a mechanical packer to carry in the HydraLock seals and expand them. As they were expanded the seal's locking mechanism secured them in place. The 18" pipe was rehabilitated in a single day.

Standard-wide HydraTite internal pipe joint seals were selected for installation in the man-entry-sized stormwater pipes, and HydraLock seals were chosen for the 18" pipe.

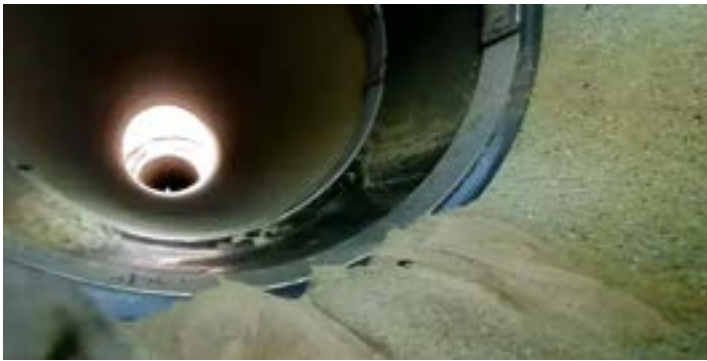
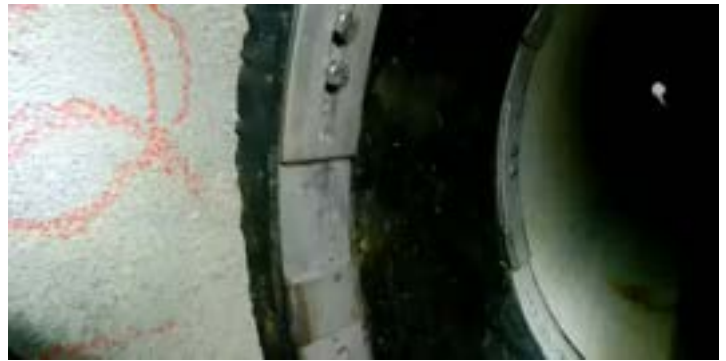
31 defective joints were scattered in man-entry-sized pipes under the subdivision. The pipes were in a roughly square mile range with the following diameters: 24", 30", and 36". HydraTech Field Services' small crew and limited tools allowed us to work around the other construction. Some roots had invaded the pipe through the joints and these had to be removed. The road was in the process of being paved and the portions that were not paved allowed mud to be washed into the pipes during rain. The pipes were cleared for our crew again and the process continued until 15 of the 24", four of the 30", and 12 of the 36" seals were all locked in place. The installation was stop-and-go due to weather and working around other construction, but the HydraTite seals were put in place in about 6 nonsequential working days.

The HydraLock and HydraTite seals prepared these pipes to serve the subdivision above. Atlantic Pipe Services and our Field Services crew restored these defective joints quickly. HydraTite was installed without disturbing other construction projects and These trenchless repairs were more cost-effective than replacement.
