# HYDRAWRAP

STRUCTURAL COMPOSITE REPAIR SYSTEM

## Challenge

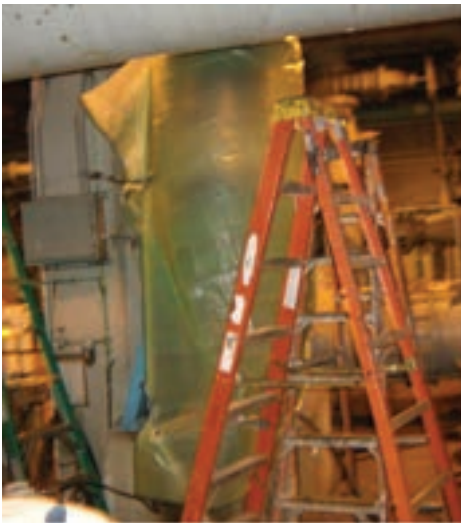
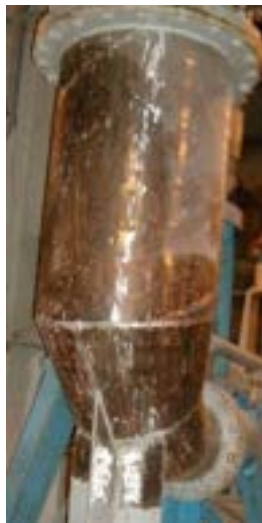
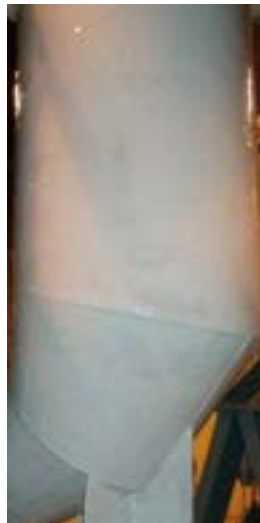
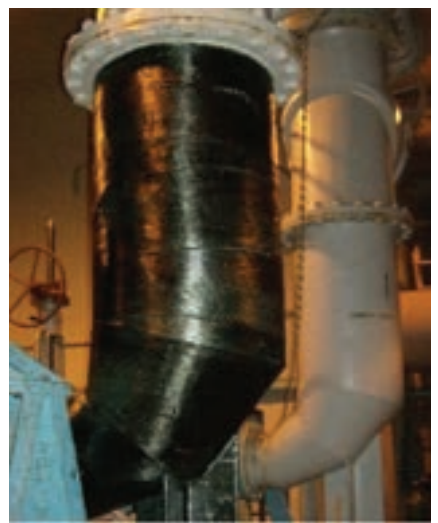
A reducing elbow at a wastewater treatment plant was experiencing leaks and small holes had formed in the carbon steel.

The surface was prepared from flange to flange of the elbow. Primer was applied, followed by four layers of HydraWrap. The repair was completed ahead of schedule.
