*Hydroelectric Plant*

Four risers that were part of a cooling water system at a power plant were showing signs of aging. Two were supply lines and two were return lines. There was extensive exterior corrosion and interior damage that was a result of frequent temperature changes. These risers were 72" in diameter and the damage was at the soil-to-air transition where the steel pipe met the bar-wrapped concrete pipe. The facility knew they needed to take action quickly when a leak was discovered.

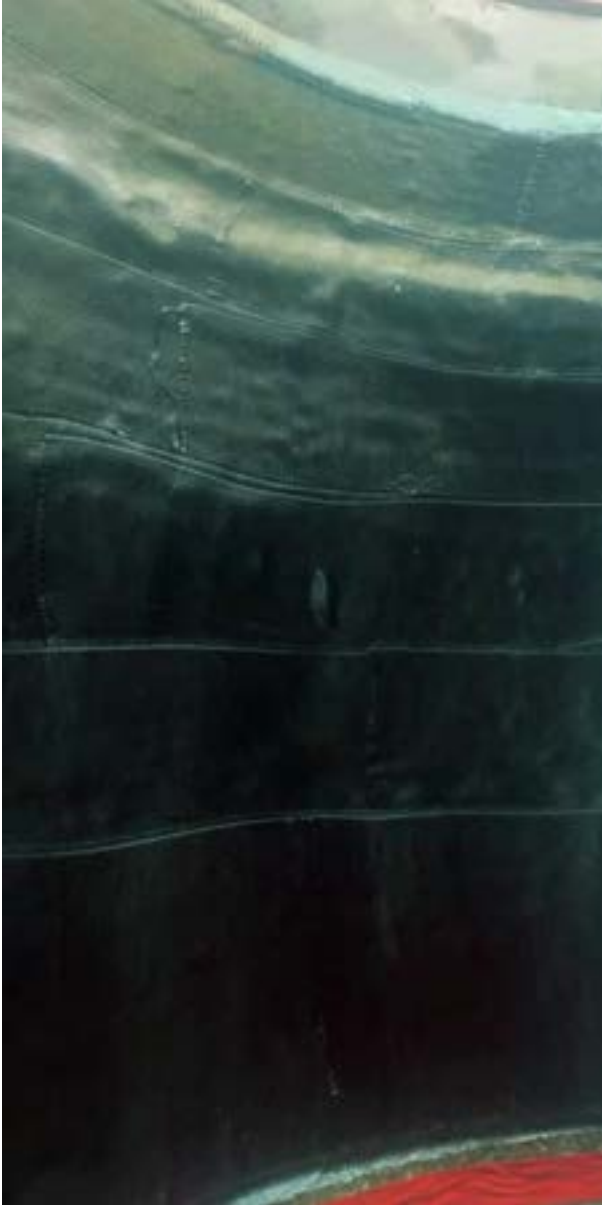
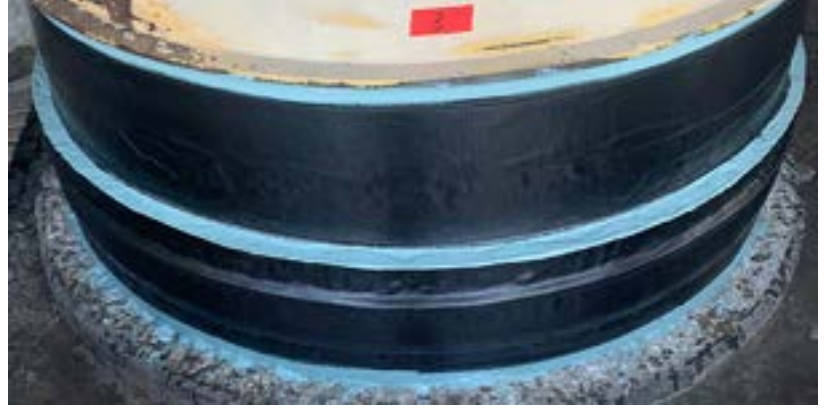
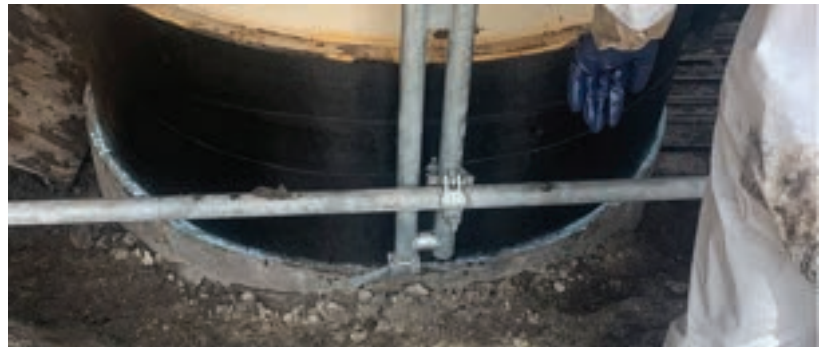
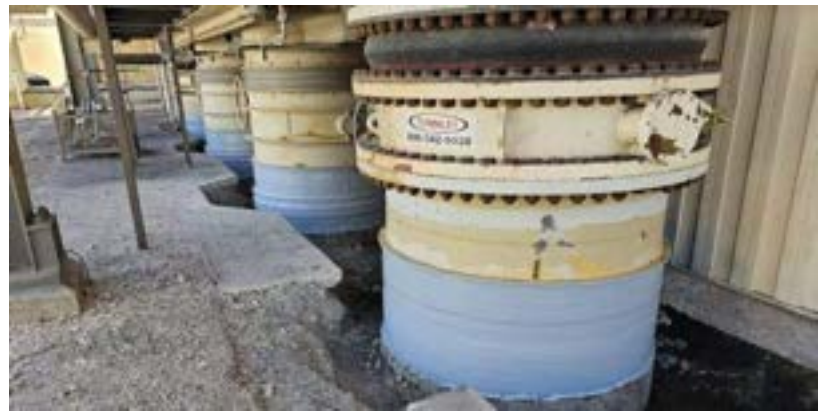
HydraLine provided a smooth uniform surface so that HydraWrap could properly be applied and bring new life to this aging system. These four risers have no leaks, new strength, and a layer of protection against corrosion. The process was less expensive and more time efficient than replacement.

The exterior was to be repaired on all four risers and two of the risers were to be repaired internally. First, the surface was grit blasted and pressure washed. Then a rust inhibitor was applied. Next, polyethylene fibers were added to HydraLine to thicken the epoxy into a malleable paste. This was then molded into the surface to restore the contour of the pipe. HydraWrap fabric was then saturated with epoxy. Eight layers were applied to the interior repairs and four layers were applied to the exterior repairs. Finally, the exterior received a weatherproof coating. The entire installation process only took four days.
