# HYDRAWRAP

STRUCTURAL COMPOSITE REPAIR SYSTEM

## Challenge

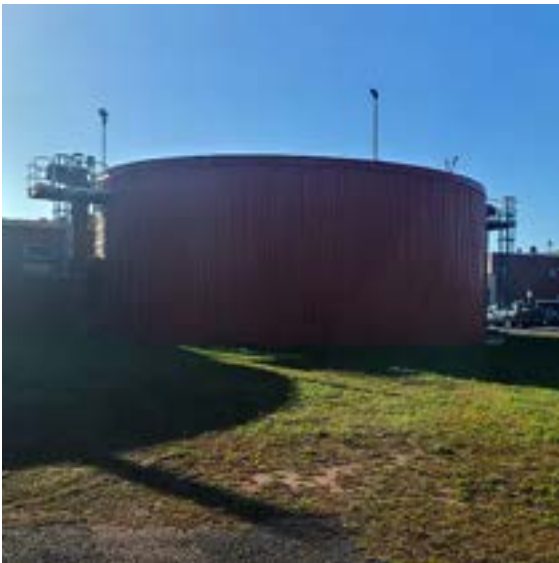
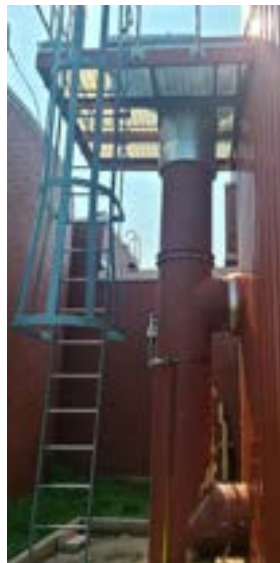
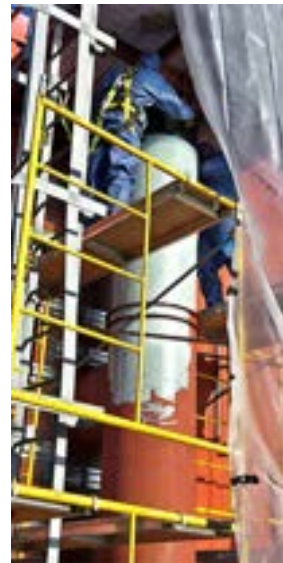
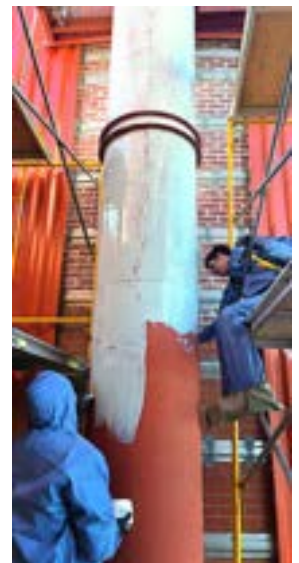
Corrosion was visible at the base of two carbon steel vertical digester mixing pipes. This corrosion had compromised the system and it had begun leaking. As a temporary measure, epoxy was used to stop the leak but the wastewater facility needed a permanent repair that could be applied without putting the system out of service.

Scaffolding was set up so that technicians could access the entire 18-foot section of pipe that needed to be repaired. Because of corrosion there was expected wall loss to this pipe, which was only 0.4" thick to begin with. Therefore, special care was taken to avoid puncturing the pipe while preparing the surface with bristle blasters. Each pipe was then coated in epoxy primer and then wrapped so that the repair area had a minimum of two layers of coverage. Between these two pipes, approximately 260 square feet of surface was wrapped in carbon fiber fabric. The project was completed with a crew of only four people. In only five days these two pipes were wrapped; surface prep was done over two days and three days were spent applying the carbon fiber fabric.

HydraWrap was the chosen solution. 12" carbon fiber fabric was to be used with standard epoxy.

Thanks to HydraWrap, the leaks were eliminated from these two vertical digester pipes. The pipes were given new strength, and the application will provide a layer of protection against future corrosion—all of this at a fraction of the time and cost associated with replacement.
